Manhole Inspection Summary

Manhole # S21A__038MH

Inspection ☐ Is Incomplete Rating: **4) Poor**

Location Address: **624 MOUNT ST**

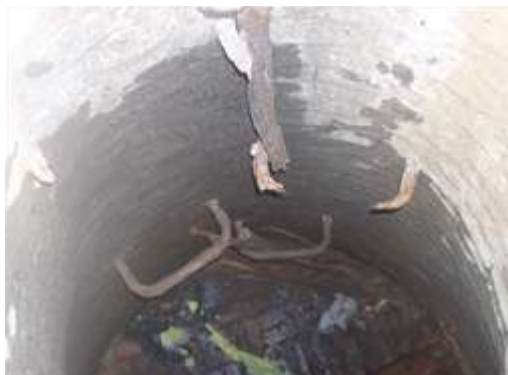
Defect 4

Count: **2** Missing: **2** ☒ **Corroded**

CORRODED AND MISSING STEPS

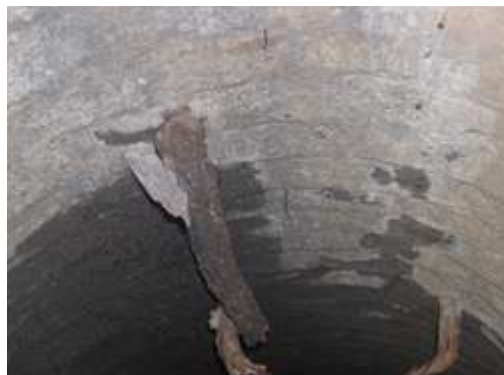
Defect 3

Infiltration: ☐ None ☐ Joint ☐ Cracks ☐ Mortar ☐ Roots ☒ **Wall**

INFILTRATION OF THE CORBEL WALL

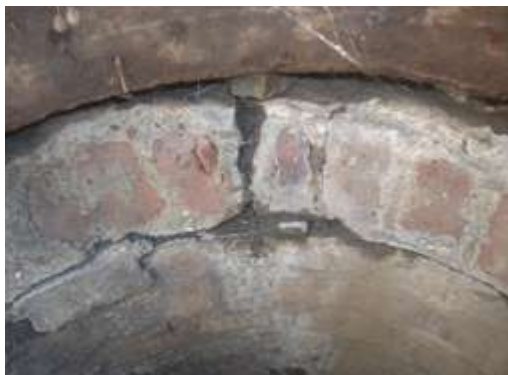
Defect 2

Condition: ☐ Sound ☒ **Cracked** ☐ Root Intrusion ☐ Loose Brick ☐ Deteriorated

Infiltration: ☐ None ☐ Joint ☒ **Cracks** ☒ **Mortar** ☐ Roots ☐ Wall

CRACKED CHIMNEY WITH
INFILTRATION EVIDENCE FROM THE
CRACK AND MORTAR

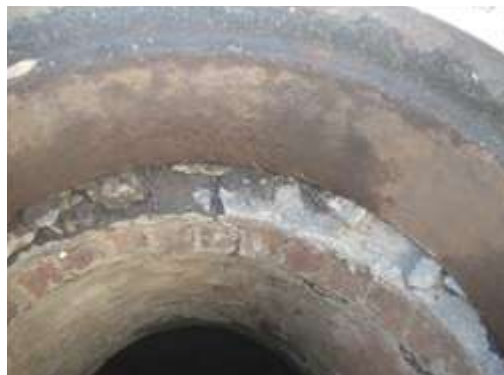
Defect 1

Offset: **1** (in.)

FRAME OFFSET and deteriorated corbel

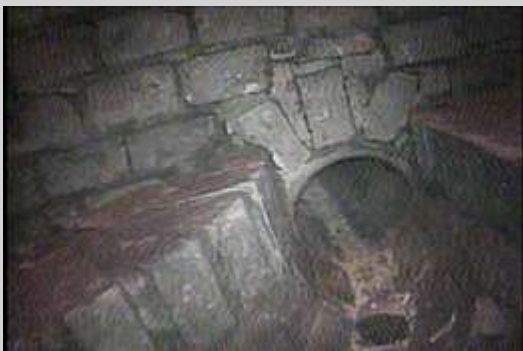
3 O'Clock Inflow

Pipe Height: **7.2** (in.) Rod and Bar (Angled)
Pipe Material: **Clay** ☐ Pipe Lined
Invert Depth: **8.31** (ft.) Flow Characteristics: **None**
Deposits: ☐ None ☒ **Mud** ☐ Sludge ☐ Debris ☐ Grease
Silt Depth: **1** (in.) Deposits Extent: **Light**
Infiltration: **None** Pipe Seal Cond: **Sound**
